ANOBIID BEETLES IN STRUCTURES

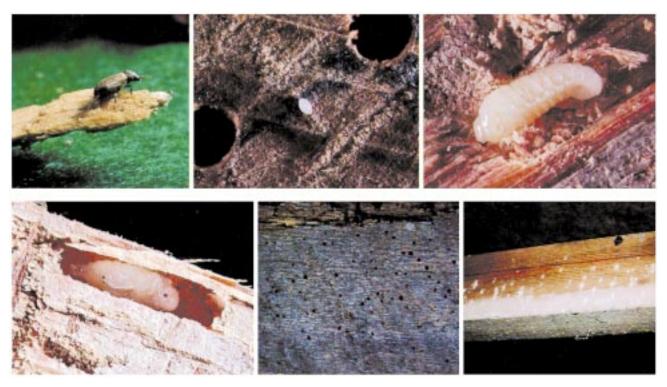
Fig. 3. Hemicoelus gibbicollis adult, top left. Fig. 4. Anobiid egg, top center. Fig. 5. Anobiid larva, top right. Fig. 6. Anobiid pupa, lower left. Fig. 7. Adult beetle exit holes, lower center. Fig. 8. Frass (feces) pushed from holes by larvae, lower right.

People rarely see these insects. Adult beetles range from 2 to 5 mm long and are reddish to chocolate brown in color (Fig. 3). Eggs are 0.5 mm long, white, and teardrop shaped (Fig. 4). Larvae are white, C-shaped, and 5 to 6 mm long when fully developed (Fig. 5). Pupation takes place just beneath the wood surface (Fig. 6).

spend 4 to 5 years in the larval form feeding on wood. In late spring and early summer, mature larvae bore tunnels to within a few millimeters of the wood surface to pupate and change into adults. Adult beetles chew a circular exit hole and emerge during June, July, and August. These holes are often seen in large numbers on a wooden surface (Fig. 7).

Since these insects are so well hidden, it is extremely difficult to determine whether an infestation is active. Finding exit holes does not always mean that anobiids still are feeding within the wood. Discovering frass as it is pushed out of exit holes is the best indicator of larval activity (Fig. 8). Remember that frass can filter out of exit holes due to normal activities in upper levels of a building. Often infestations will die out for undetermined reasons. Before undertaking control measures, have the building inspected and try to determine infestation levels. To check for new frass being expelled, place a black background under areas that are suspect for several weeks during summer months, or paint portions of wooden surfaces to look for new adult exit holes. Researchers are currently testing light traps to catch adult beetles in crawl spaces. Low levels of activity (that is, a few exit holes in one or two boards in the building) do not warrant control.
